**PRELIMINARY ASSESSMENT/
VISUAL SITE INSPECTION**

**WELLMAN THERMAL SYSTEMS, INC.
SHELBYVILLE, INDIANA
IND096173984**

FINAL REPORT

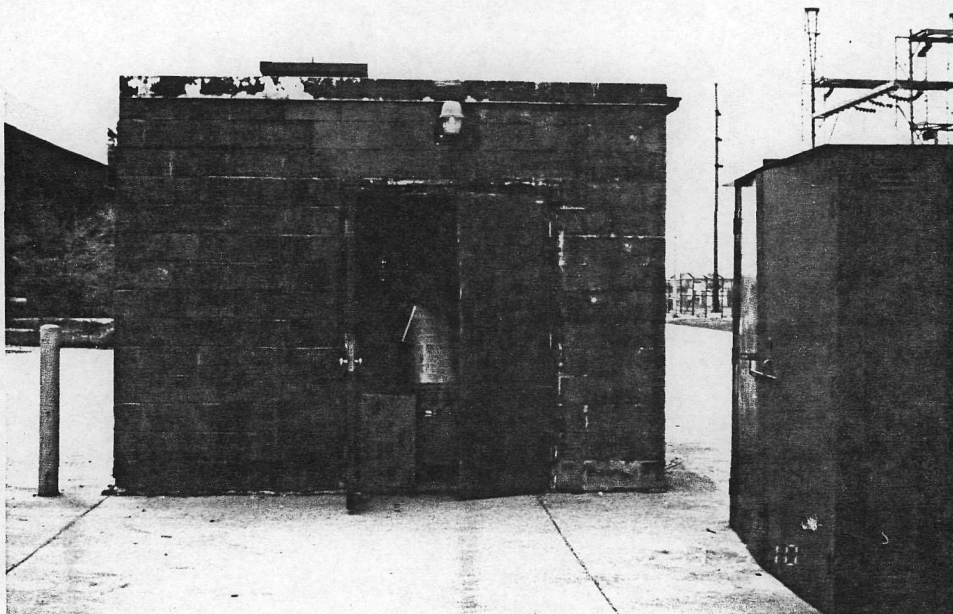
Photograph No. 1

Only the building that housed this unit remains. The building is in poor condition and is now used for storing shelves and empty drums. PRC noted no evidence of release. See Photographs No. 1 and No. 2.

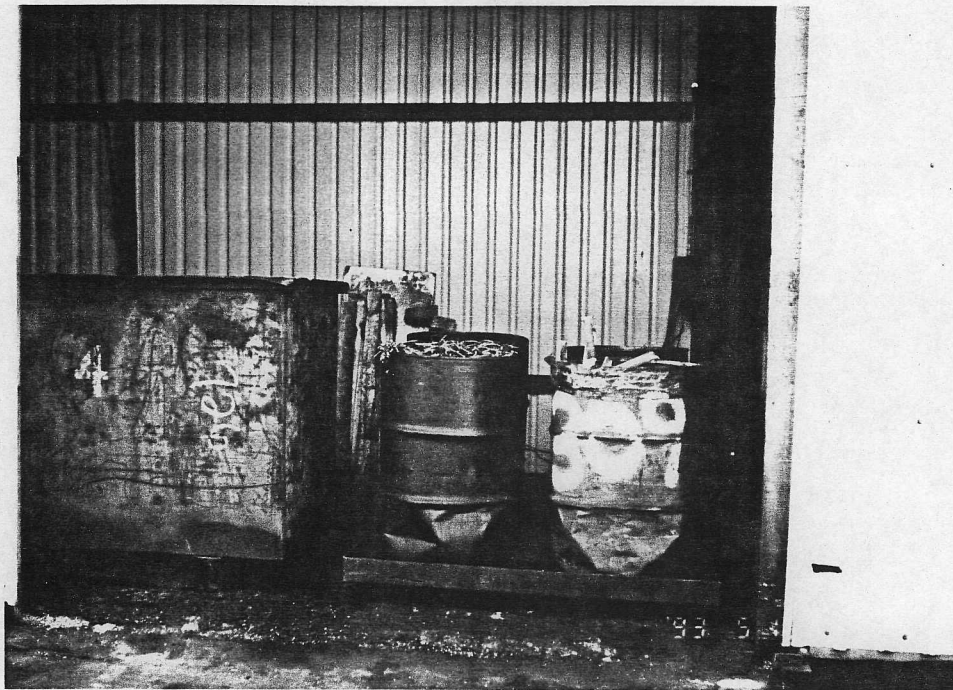
Observations: The unit contained two hoppers and four open 55-gallon steel drums during the VSI. All of the containers were 3/4 full of scrap metal coated with oil. PRC noted that there was extensive oil staining on the floor of the unit. There was no dike around the perimeter of the unit, and a 1/2-inch gap is present between the building wall and the concrete floor. See Photographs No. 5 and No. 6.

Photograph No. 5
 Orientation: West
 Description: Drums and hopper in waste oil storage area.

Recommendations: PRC recommends cleaning this unit's floor and sampling soil around the perimeter of the building to determine whether soils are contaminated. A berm should be built around the interior of the unit or the 1/2-inch gap between the walls and floor should be filled in.

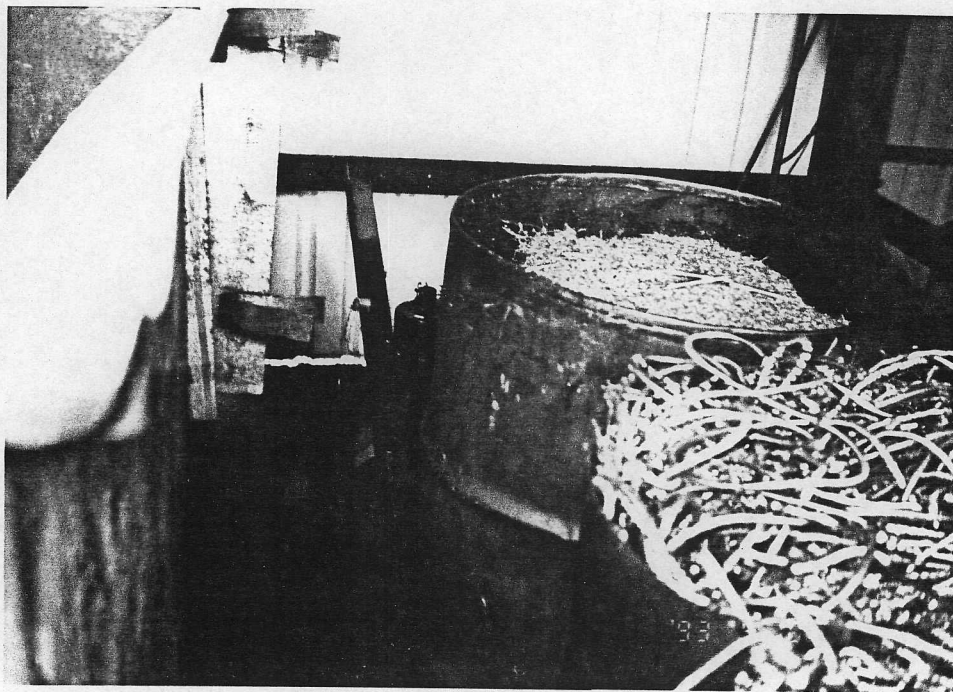
Photograph No. 6
 Orientation: West
 Description: Closeup of closed sump and drums in waste oil storage area.

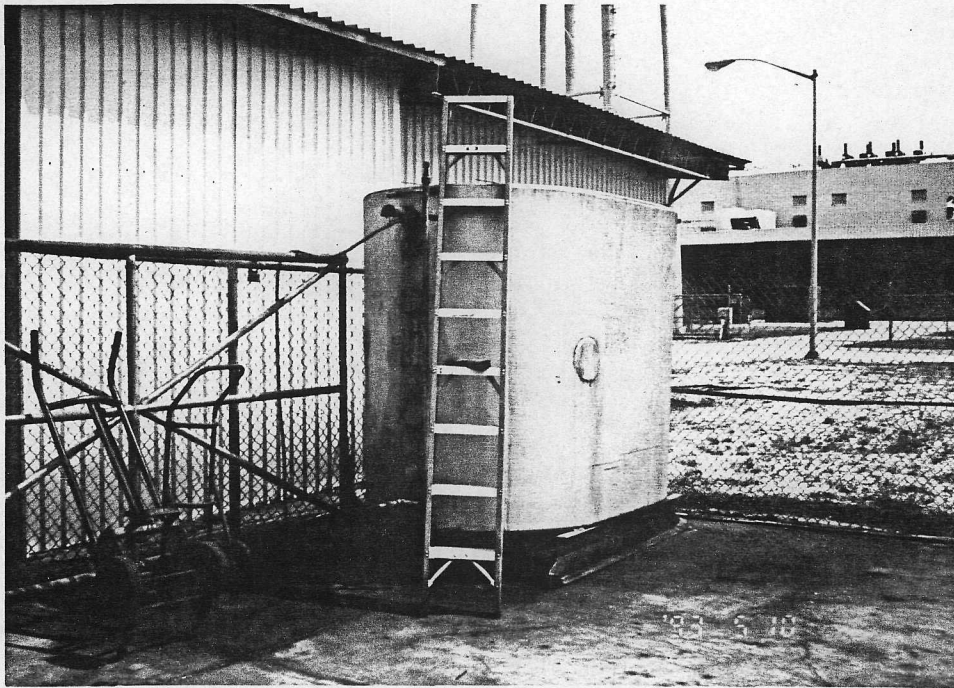
Photograph No. 7

Observations: No monitoring devices were present on this unit. Oil staining was present on the concrete pad and outside the fence on the soil. The concrete was free of cracks. See Photograph No. 7.

Description: One thousand-gallon aboveground tank for waste oil. Soil staining is present to the south of the tank and on the concrete pad.

Recommendations: A berm should be built around the concrete pad, and overflow monitoring devices should be attached to the unit. Soil sampling should be done around the perimeter of SWMU 7 to determine whether soil has been contaminated.

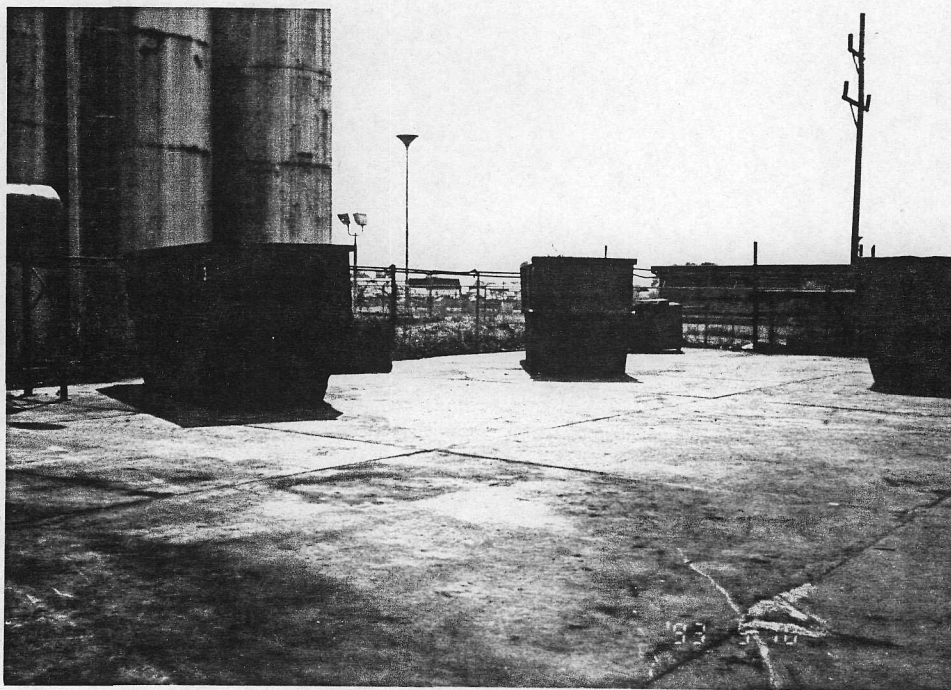
Photograph No. 8

Observations: The three 10-cubic-yard hoppers and one 20-cubic-yard hopper were approximately half full of various scrap metal during the VSI. The hoppers were in good condition. The concrete under the hoppers had a few small cracks. PRC noted no evidence of release. See Photograph No. 8.

Description: In the foreground are the hoppers and concrete pad of the scrap metal storage area. In the background are the aboveground fuel tanks.

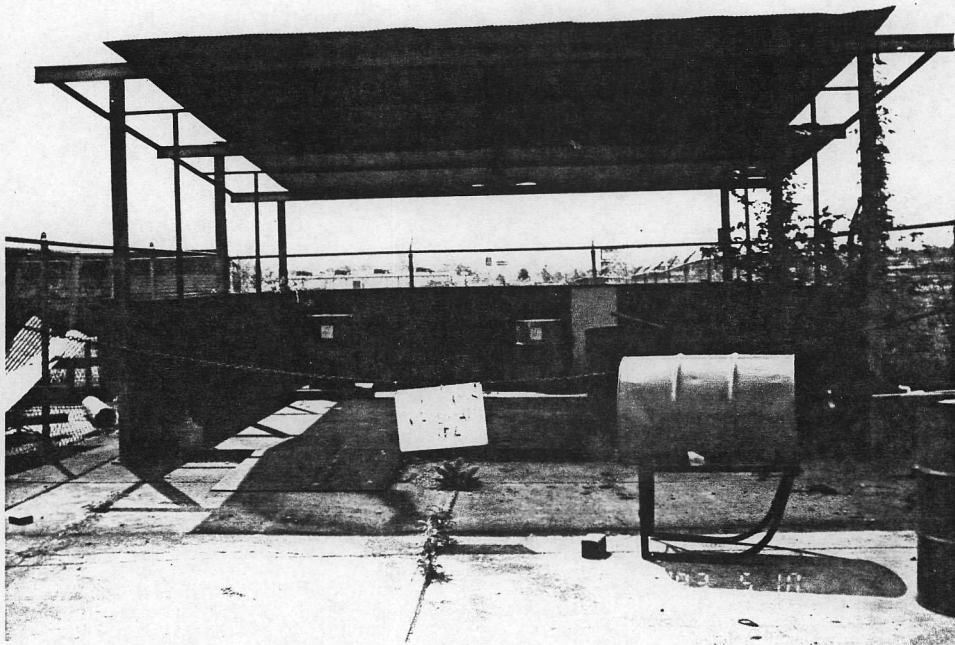
Photograph No. 9

The unit contained two 55-gallon drums of a waste paint and spent xylene solvent mixture, listed as F003 waste. Both drums were sealed and in good condition. The unit also contained three open, empty drums and a one-gallon canister with unknown contents. There were a few 1/2-inch-wide cracks running through the center of the concrete floor, and plants were growing between the cracks. This unit is fenced in and secured with a chain across the front of the unit. PRC noted no evidence of release. See Photograph No. 9.

Observations: The container and concrete pad in this unit were in good condition. PRC noted no evidence of release. See Photograph No. 9.

Recommendations: The facility should repair the cracks in the concrete pad and continue managing containers to minimize releases to on-site soils and groundwater.

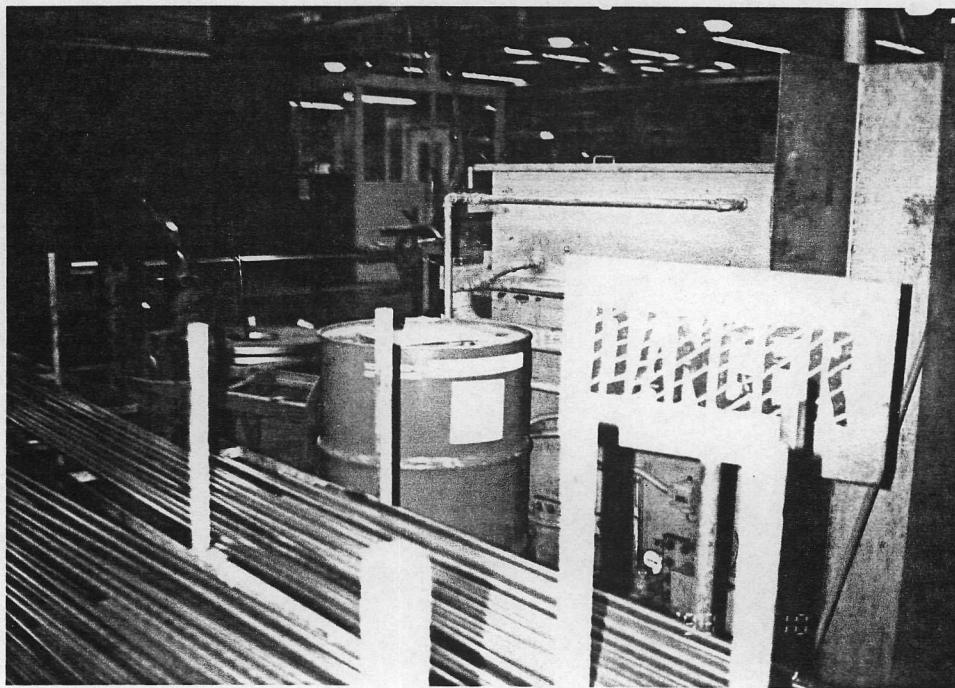
Photograph No. 10

Observations: This unit contained a 55-gallon steel drum with an unknown quantity of TCE. The drum was in good condition and closed. The concrete floor under the drum contained no cracks. PRC noted no evidence of release. See Photograph No. 10.

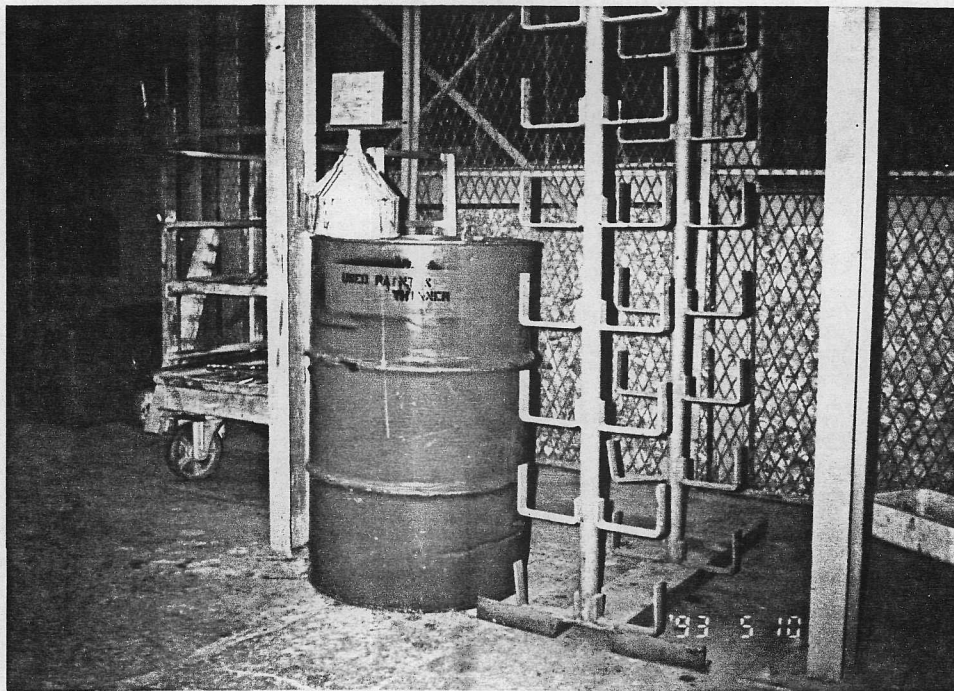
Observations: This unit contained one 55-gallon steel drum at each of three locations. PRC was shown only two paint-related waste SAAs. The drums contained unknown quantities of waste during the VSI. The drum near the paint booth had extensive paint staining on it. Paint

stains were also noted on the floor near it. The other drum near the heavy assembly area was in good condition. Both drums contained open funnels on their tops and odors were emanating from them. The floor below each had no cracks. See Photographs No. 11 and No. 12.

Photograph No. 11
 Orientation: East
 Description: An SAA for paint-related wastes.

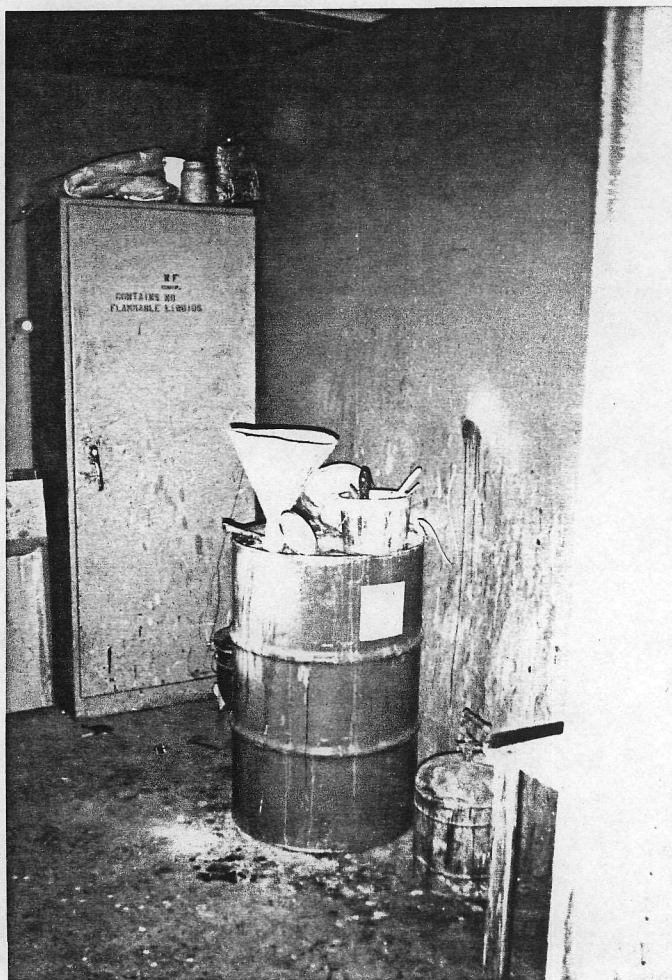
Photograph No. 12
 Location: SWMU 4
 Orientation: North
 Date: 5/10/93
 Description: An SAA for paint-related wastes.
